COMMERCIAL INSPECTION REPORT

MINI STORAGE
123 Any St
Any Town, Texas 11111

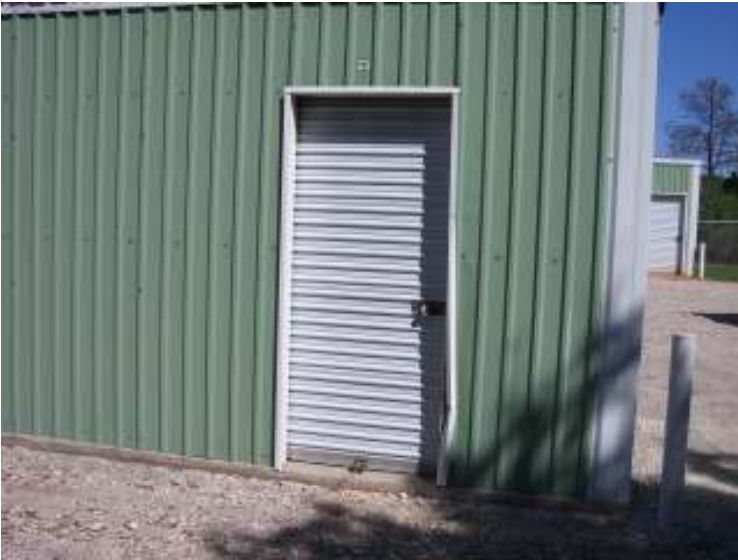
Unit 25 has sustained damaged to door frame.

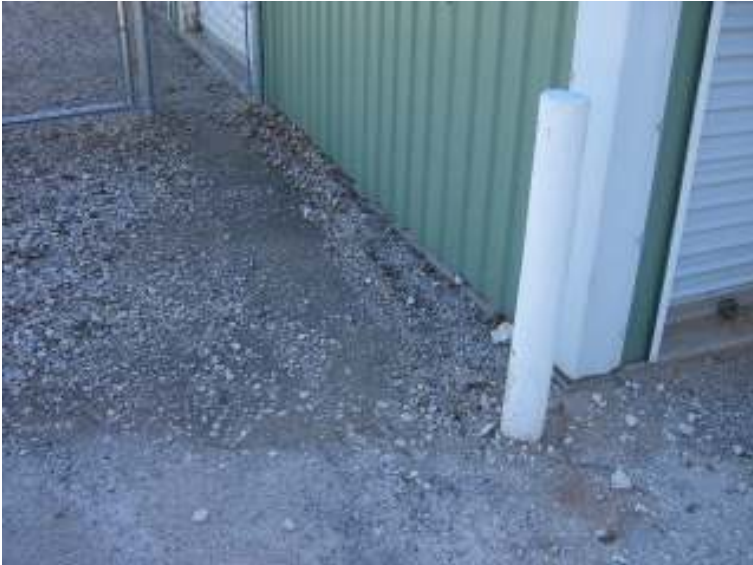
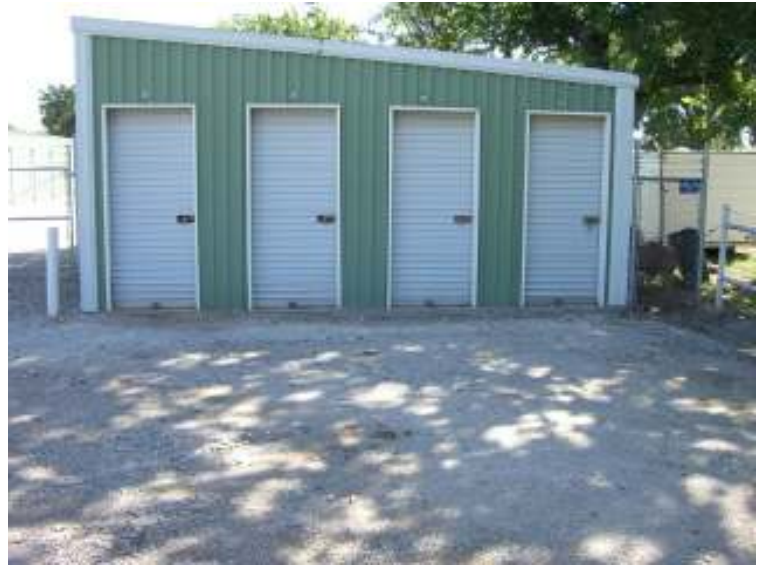
Drainage needs to be corrected in front

While on the property, the neighbor that lives directly to the right of the facility approached me and stated that the drainage from the front of the facility is draining onto his property and that the current owner had recently attempted to correct the drainage but was unsuccessful. The photograph from building three will show a ditch that has been recently been dug to correct the drainage problem. In my opinion, "all gravel road surfaces should have drainage swells installed to manage any water accumulation during inclement weather conditions".

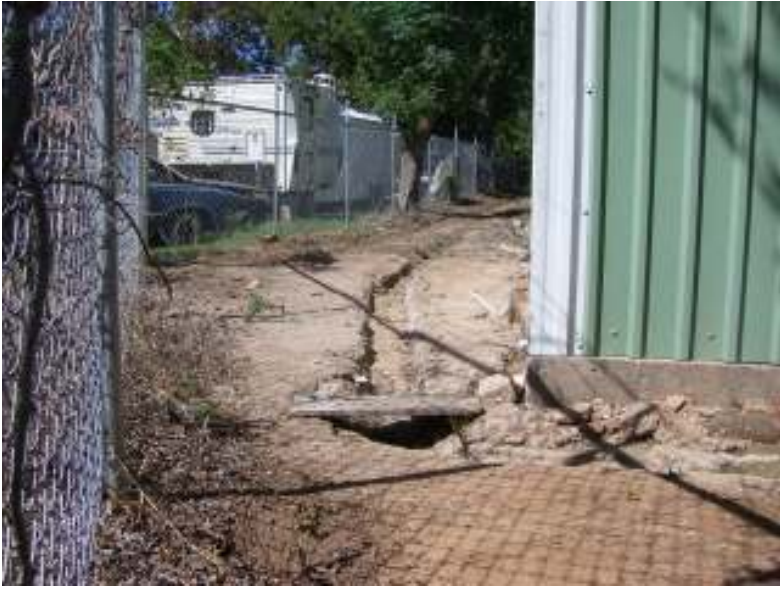
Drainage on right side of property needs to be corrected. However, right side of building did not show evidence of water entering any unit from exterior view.

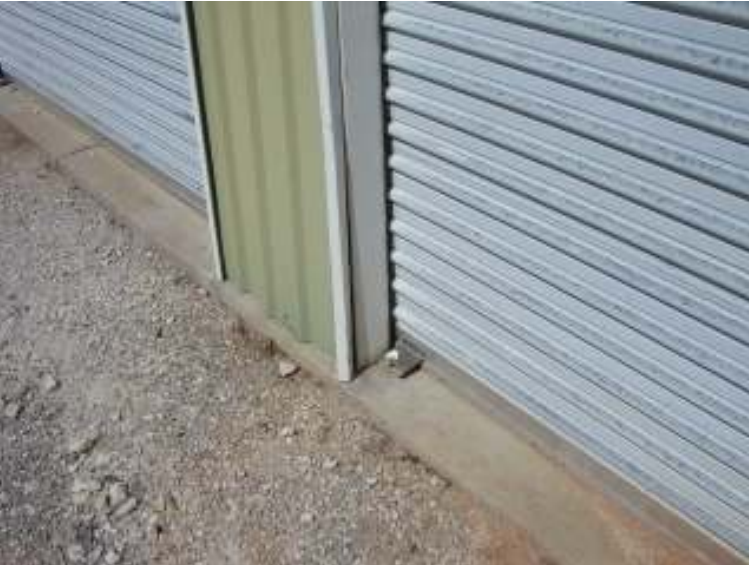
Damaged door frame on unit 61

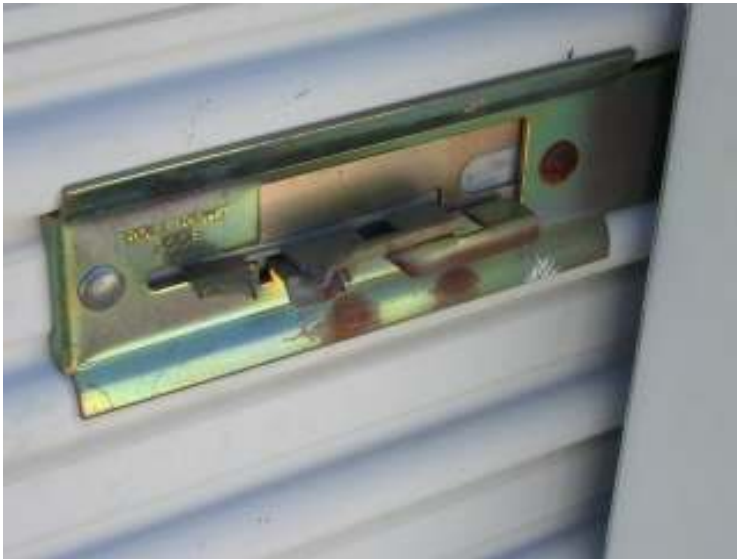
Unit 111 has damaged lock clasp.

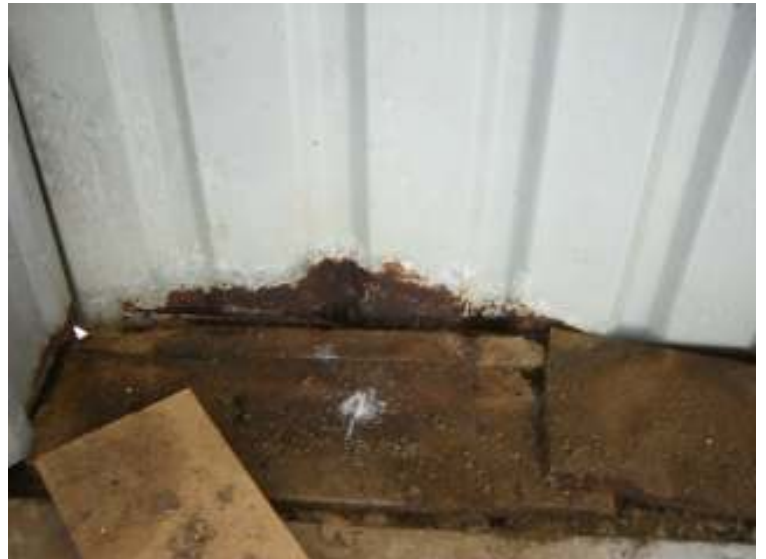
Unit 114 has rusted wall panel

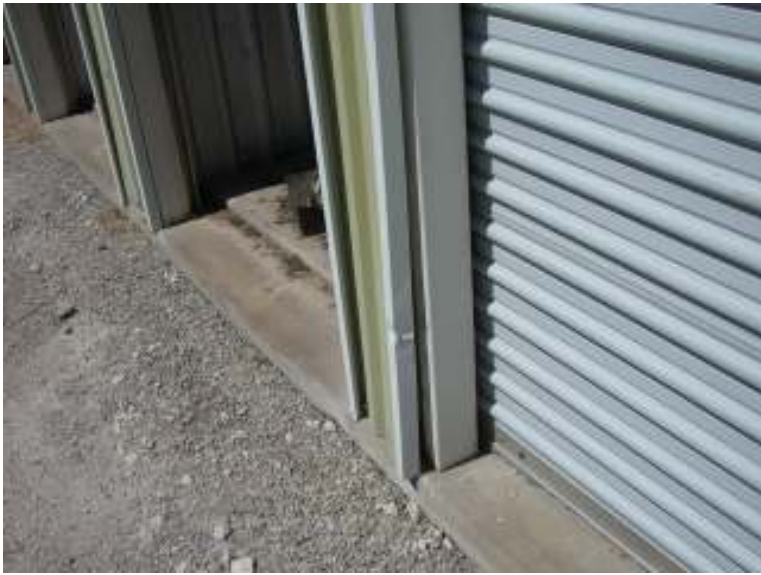
Unit 105 Has damaged door frame.

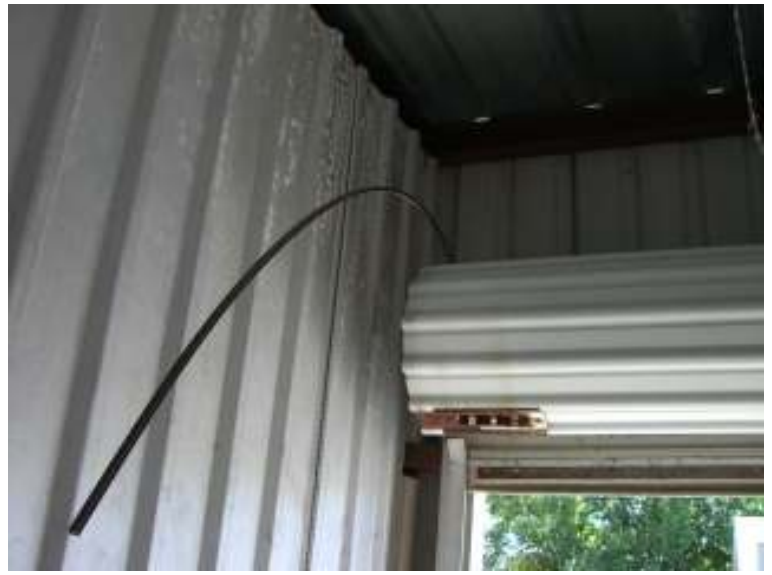
Unit 104 needs weather strip re-installed.

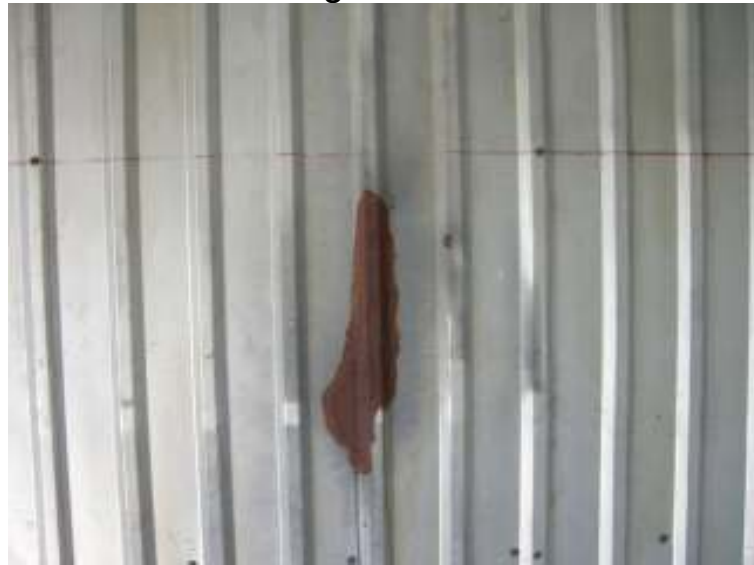
Unit 97 has some rust on interior wall surface.

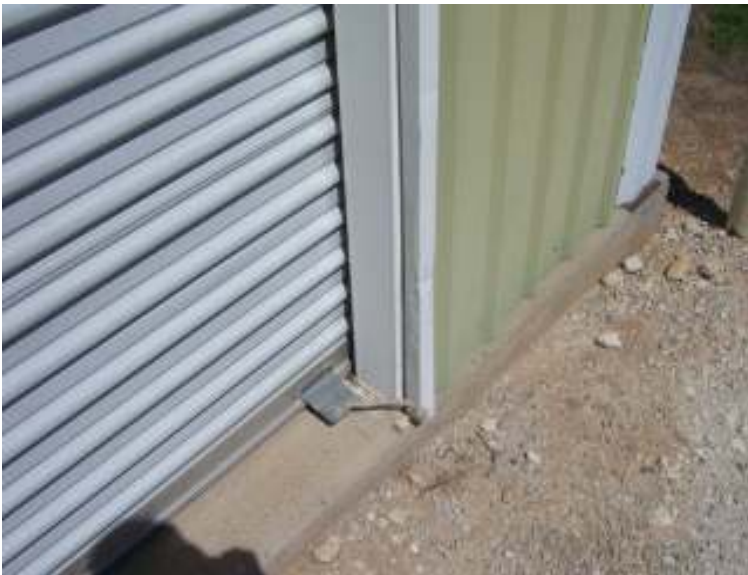
Unit 137 has damaged door frame.

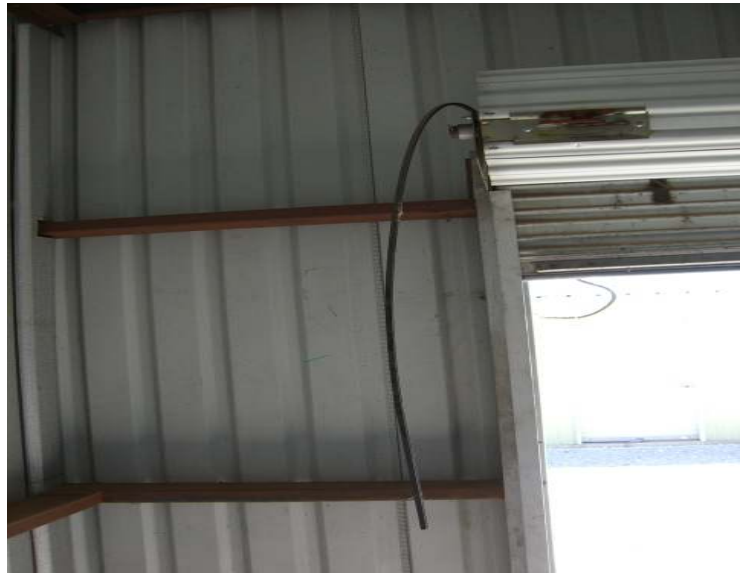
Units 128 and 130 has loose weather strip.

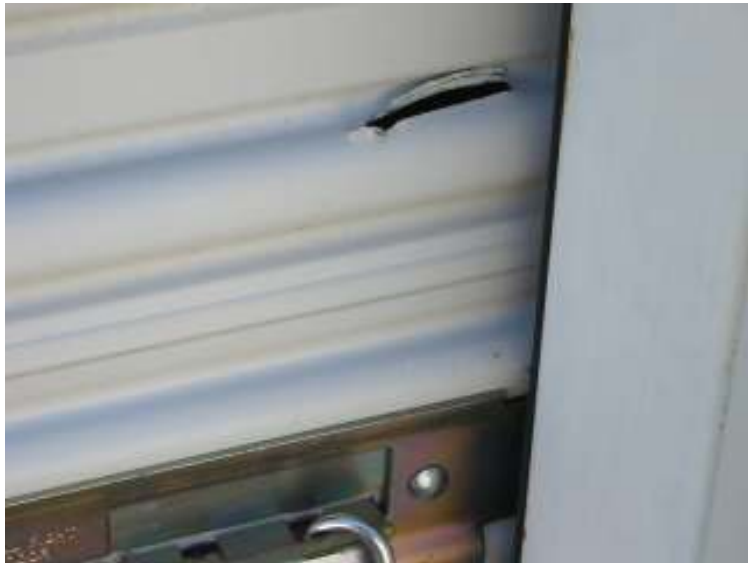
Unit 145 has a damaged door panel.

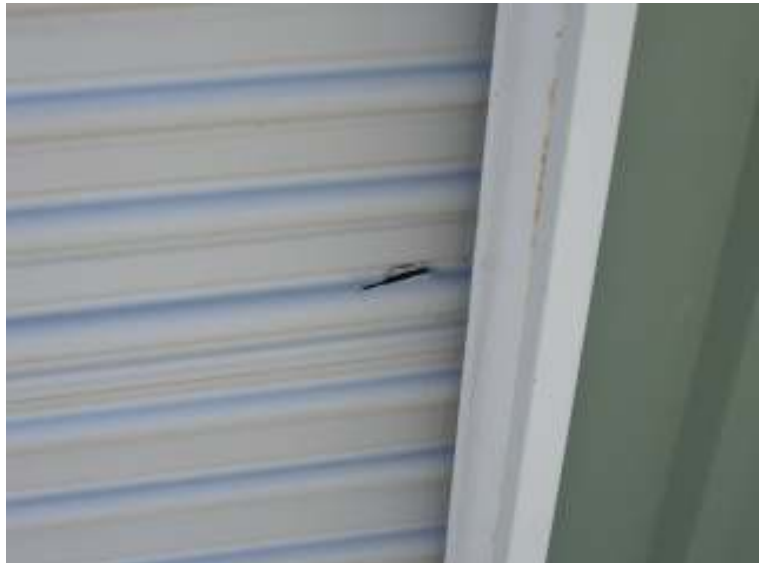
Unit 153 has a damaged door panel.
