Home Inspection Report

PROPERTY INSPECTION REPORT

Report #: One Year Warran

Concerning: TX
(Address of Inspected Property)

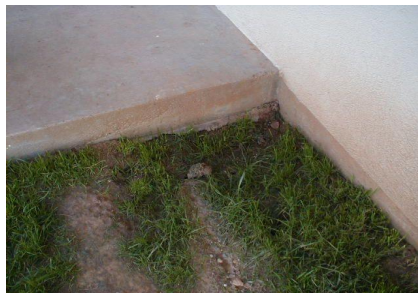
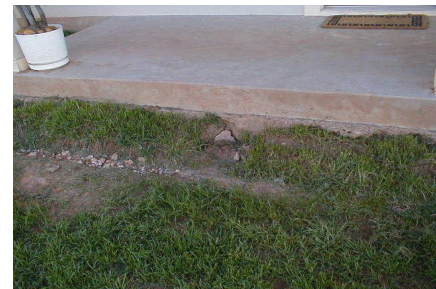
B. Grading & Drainage

- ␣ Improper drainage from foundation
 - Gutters draining too close to the structure
 - Trees/heavy foliage too close to the structure
 - ⋮ Planter(s) adjoining the structure
 - ␣ Dirt slopes towards foundation
 - ␣ Signs of ponding along foundation
- Grading and drainage are not in compliance. Most areas and perimeter are in need of fill dirt to prevent ponding. Additional there are no rain gutters to prevent erosion.
- ␣ Erosion or ponding next to foundation/driveway
 - Plumbing leaks/Hose Bibs/Sprinkler System
 - ⋮ A/C condensation line terminates too close to structure
 - ␣ Inadequate grading clearance to exterior wall surface
 - ␣ Drainage needs to be corrected

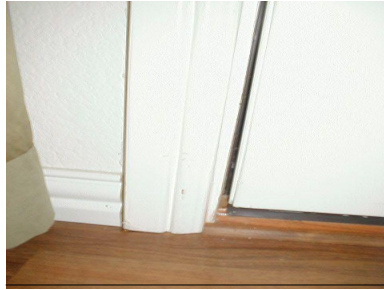
Doors sealed poorly at: all six exterior doors all show signs of misalignment.

- .. **Doors do not latch properly at: all exterior doors**
- Doors rub, stick or hit the frames at: _____
- Door locks or doorknobs are in need of repair at: _____
- .. **Deadbolt locks, do not extend to properly lock the doors at: Master bedroom door to patio, at living room door to patio and at both exterior doors of mother in law quarters.**

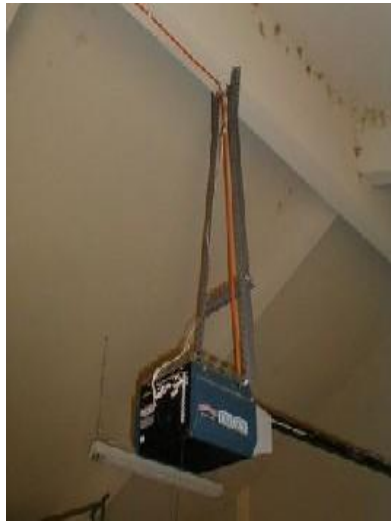
- Some fastening hardware loose
- Doors and/or panels are water damaged
- Dedicated plug in for garage door is missing.**
- Door locking hardware is loose and/or missing
- Tension springs are not safely secured
- Connection door from garage to house is not fire rated.**

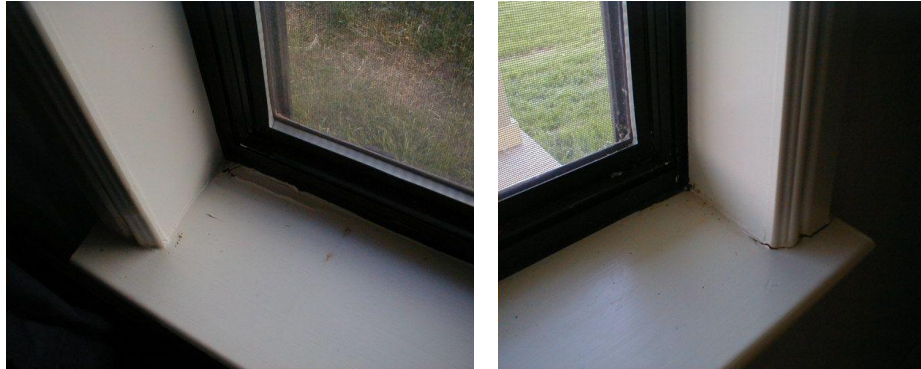
.. Storm windows installed are a safety hazard, if they do not provide adequate egress in the event of a fire
 p Observed signs of water intrusion. Condensation accumulation at window stools resulting in paint and wood deterioration. Possible cause is lack of insulation surrounding fenestration.

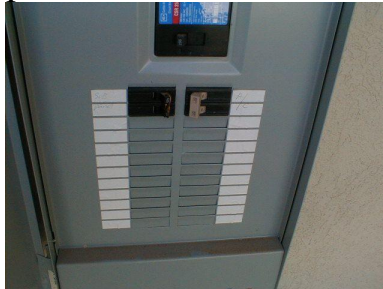
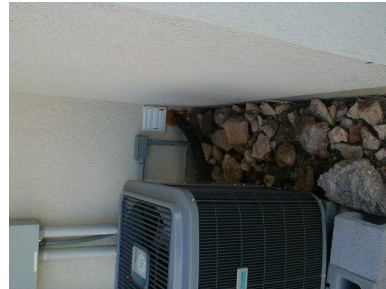
- Ⓟ Panel(s) are not labeled properly
- " Panel(s) are loose at the wall
- " One or more knockouts are missing
- " Double lugged breakers/fuses
- Ⓟ Incorrect size of breakers/fuses
- Ⓟ A/C condensing unit #1 specifies max amp breaker of 20 and a 30 amp breaker is in use
- Ⓟ Space in front of breaker panel not up to standard(30 inches). Space blocked by A/C.
- Ⓟ breaker manufacturer different to panel manufacturer Ⓟ Rust flakes observed in breaker panel.
- Main sub panel is lacking an approved handle tie on 125 Amp breaker (tied with copper wire.)
- Ⓟ breaker tie not up to standard of manufacturer (tied with copper wire.)

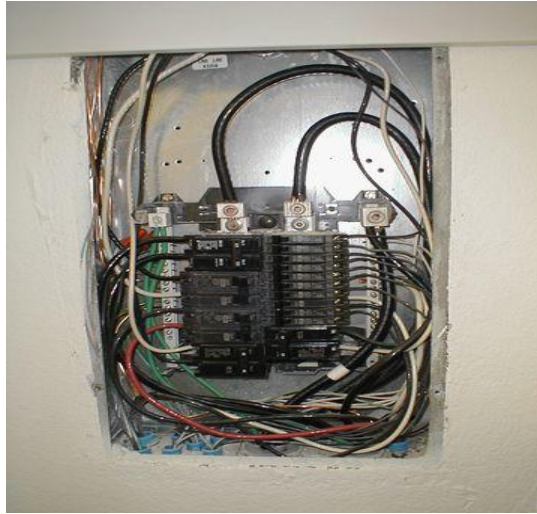
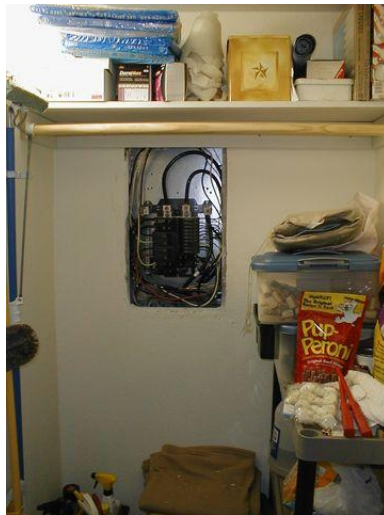
- Ⓟ Panel(s) are not labeled properly
- " Panel cover(s) are loose at the wall
- " Double lugged breakers/fuses in use
- Ⓟ Incorrect size of breakers/fuses
- Ⓟ too crowded (40% space required)
- Ⓟ breaker manufacturer different to panel manufacturer
- Ⓟ Incorrect size wire on breaker/fuse (three different wire sizes on same size of breaker)
- Ⓟ A/C condensing unit #2 specifies max amp breaker of 20 and a 30 amp breaker is in use
- Ⓟ A/C condensing unit #3 specifies max amp breaker of 20 and a 30 amp breaker is in use
- Ⓟ Paint splashes in panel

- Ⓟ Panel(s) installed at improper location (Closet)
- " Inadequate service space for sub panel
- " One or more knockouts missing
- " Grounds and neutrals on same bus bar (typical of older home installations)

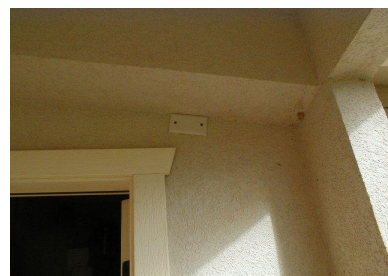
improper cover for outside junction box on west side of garage

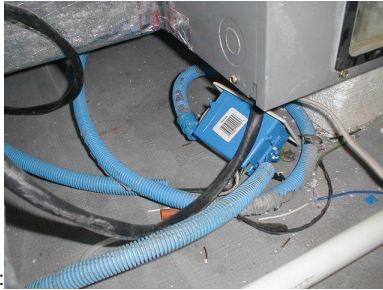
Loose/damaged/missing outlets and/or covers attic. Electrical boxes not tied in.

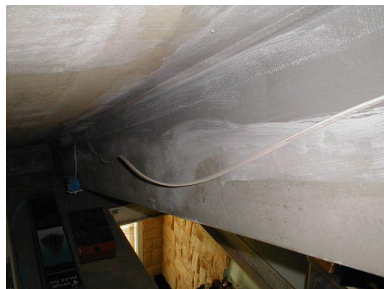
Switch in main living room seems to have no connection. Romax cable at entries of attics within 6 feet are not protected. Romax cable is not supported correctly in attics.

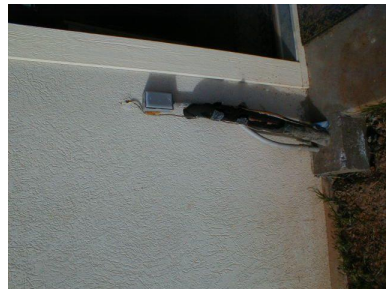
Ⓟ Freon lines not properly insulated at outside of building. As they are not protected, insulation and line itself are subject to damage

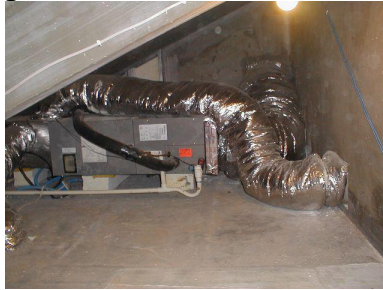
- ⌘ Condenser(s) installed too close to structure < 18 " ** Termination of condensate line is inadequate
- ⌘ No auxiliary drain on attic unit

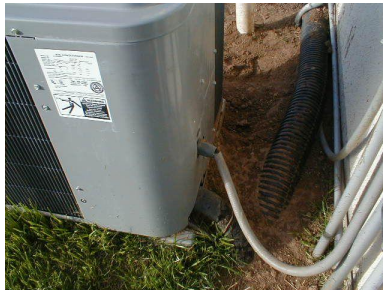
- ⌘ Electric connection at condenser unit is pulling apart and also freon vapor line is laying on ground and is not buried and therefore subject to damage.

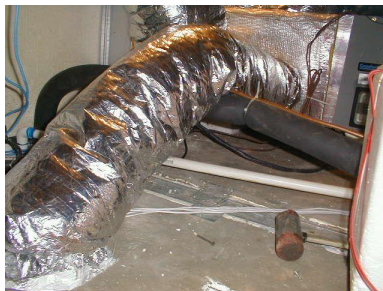
- ⌘ Ducting is kinked or restricted in one or more places affecting airflow, and not supported properly.
- ** Some ducting moisture barrier is damaged, missing and/or deteriorated
- ** There is no central airflow to the room addition(s) and/or garage conversions

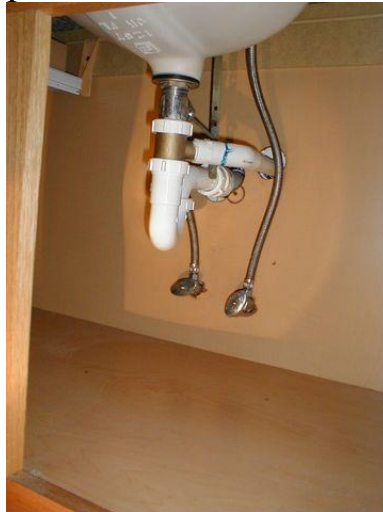
Ⓟ Noaround waterline after entry through wall underneath basin.

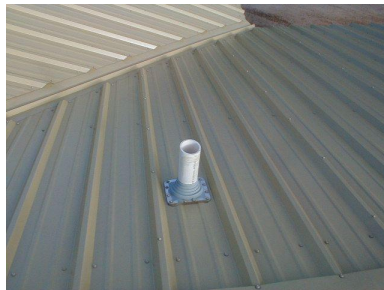
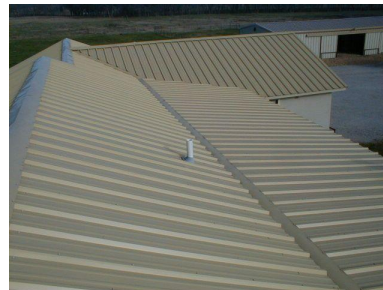
Ⓟ Vents on roof are missing UV protection

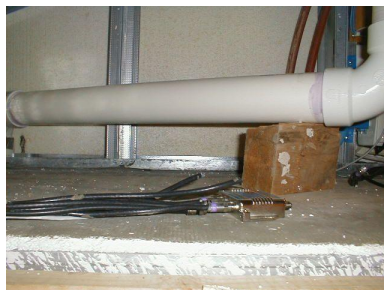
Ⓟ vent pipes in attic not correctly supported.

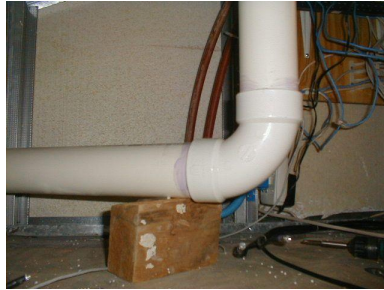
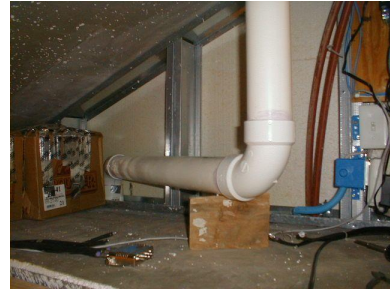
⌋ vent pipes in attic have 90 degree angle shortly after entering the roof, thus collecting water.

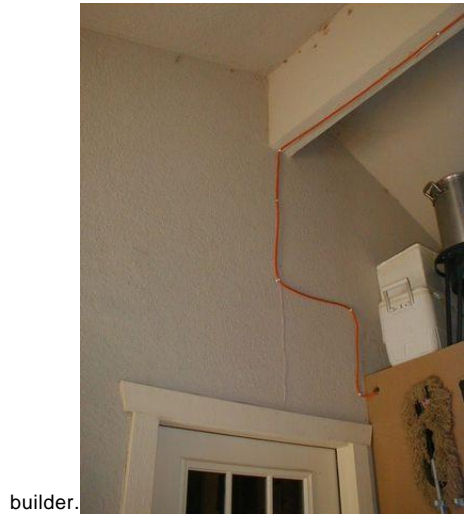
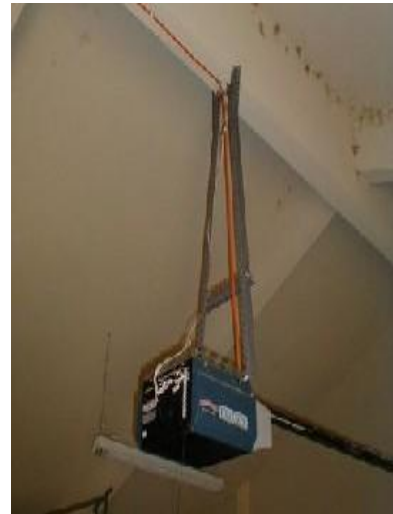
- ** Auto safety reverse does not work - Safety Hazard ** Switch is installed within reach of children
 - ** Missing safety wire inside door springs ** Switch is loose or too damaged to operate opener
 - ** Electronic sensors not installed at proper heights ** Unit(s) are loose or not properly secured to ceiling
 - ** Electronic sensors do not operate ** No safety quick release rope to disable opener
- Garage door opener is attached by extension cord to non dedicated receptacle and is therefore not up to standards an in need of repair. Owner had to connect with extension cord, as no dedicated receptacle was provided by

builder.
