# Real Estate Inspection Report

123 Any St., Any Town, TX

PROPERTY INSPECTION REPORT

Report #: SLC20061119-01
Prepared For: John & Mary Doe (Name of Client)
Concerning: 123 Any St., Any Town, TX 11111 (Address of Inspected Property)
By: Steven L Chastain, #8057 (Name and License Number of Inspector) 11/19/2006 (Date)

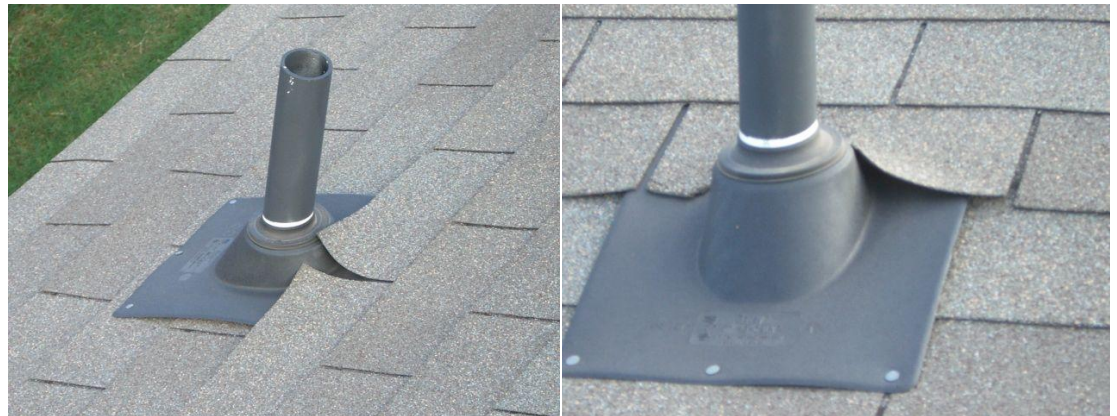
Shingles around roof penetrations need to be trimmed and sealed to prevent wind damage or wind driven rain intrusion.

**The roof covering is in need of replacement or repairs, a Certified Roofing Contractor should be consulted.**

▷ Shingles around roof penetrations need to be trimmed and sealed to prevent wind damage or wind driven rain intrusion.
